2006

Problems With Fire Station Floor

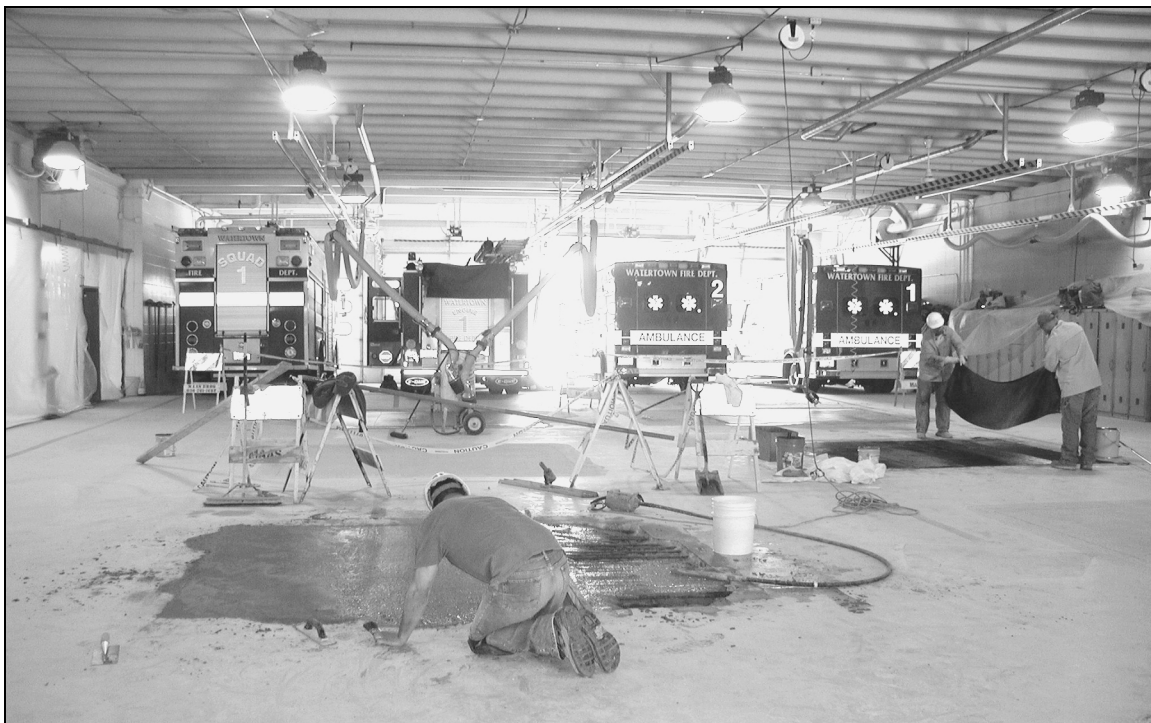
WHS_006_270

Jeff Kossman of J K Architecture and Engineering looked at three different options and the associated costs necessary to fix the floor in the Fire Department garage or apparatus area that was cracking under the weight of the emergency vehicles.⁵⁰

The last engineering study that was done 10 years ago on the Fire Department floor, which is about 50 years old, showed that when the floor was constructed it was not built to what the modern standard is.

Workmen preparing rectangular areas in garage floor (between supporting columns in the basement below) for carbon fiber reinforced fiberglass matting and composite application.

The Watertown Common Council decided to repair the cracking floor of the Fire Department garage with a carbon fiber reinforced fiberglass system, awarding the contract to Maas Brothers in Watertown for about \$387,000.⁵¹

The carbon fiber reinforced fiberglass system was more favorable because it will give more strength to the floor in addition to keeping the basement fully accessible. The carbon fiber reinforced fiberglass system was expected to permanently fix the cracking problem.
